Re: Spring 2010 Re-Vegetation Monitoring Report

1 1/2 Mile Reach Removal Action

GE-Pittsfield/Housatonic River Site, Pittsfield, MA

Spring 2010 Re-Vegetation Monitoring Report

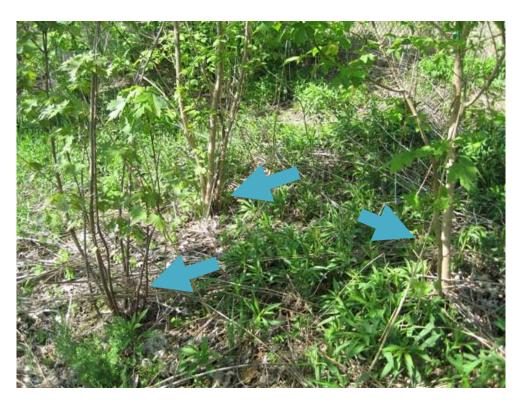
Photo 5: Example of three trees that may need to be pruned then caged.

- 2. Numerous volunteers above, below, and within the rip-rap were observed throughout this sub-reach.
- 3. The need for installation of tree cages was identified for some of the large volunteers along the western shoreline in the area between Monitoring Plot 1-W-1 and 1-W-2 (i.e., upstream of the Silver Lake outfall).

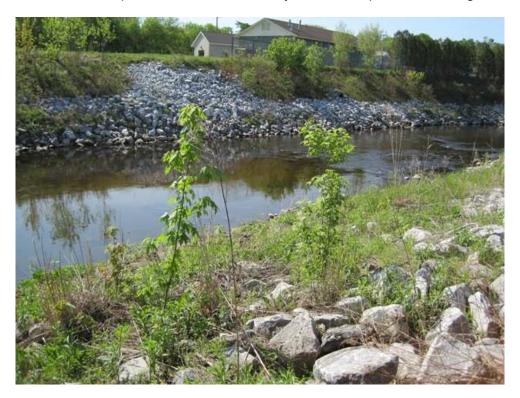
Photo 6: Example of two trees that need to be caged.

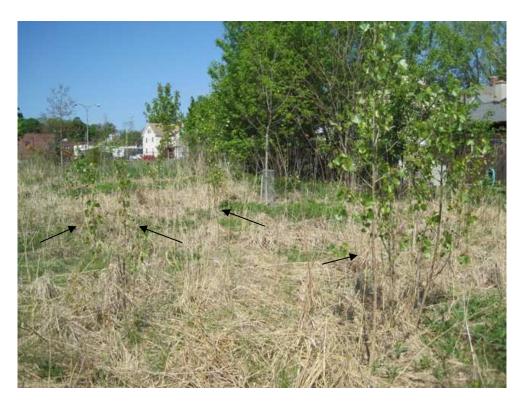
Photo 7: Example of numerous first and second year eastern cottonwood volunteer saplings appearing within Parcel I8-24-1.

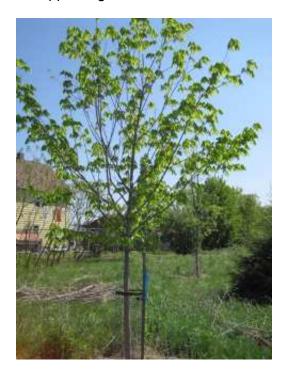
- 7. A preliminary examination of the four trees on Parcel I8-24-1 that were scheduled for assessment in 2010 produced the following findings:
 - a. In 2009, a red maple that had been planted to replace a dead oak in 2008 was found to be stressed. That red maple was observed to be healthy in spring 2010.

Photo 8: One of four trees monitored on Parcel I8-24-1. This red maple was considered to be healthy.

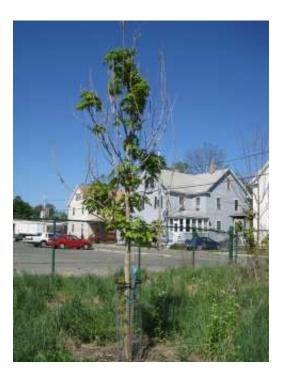
- b. In 2009, a sugar maple that had been planted to replace a dead oak in 2008 was found to be stressed. That sugar maple still appeared to be stressed in spring 2010.

Photo 9: One of four trees monitored on Parcel I8-24-1. This sugar maple was considered to be stressed.

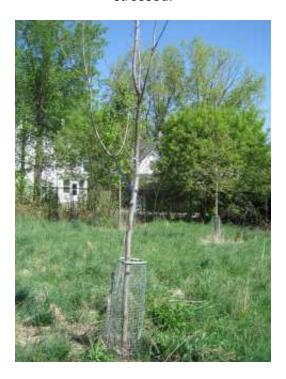
- c. In 2009, a white oak was planted to replace a dead white ash. That new white oak was observed to be healthy in spring.
 - d. In 2009, another white ash was observed to be stressed. That white ash was observed to be dead in spring 2010.

Photo 10: One of four trees monitored on Parcel I8-24-1. This white ash was considered to be dead.

The results of the spring 2010 monitoring visit for the 1½ Mile Reach revealed that, despite a few areas of concern, the riverbank plantings in all the sub-reaches, as well as the non-riverbank plantings at Parcel I7-1-101, are exhibiting very good growth. This survey also indicated that the designated monitoring plots are representative of the overall monitoring areas that they were designed to represent. In addition, there were no obvious gaps in the red-osier dogwood band at the bottom of the re-vegetated slope, and there were no significant areas of bare soil observed (only a number of small areas were observed within Monitoring Plot 3-W-3). Numerous volunteer species above, below, and within the rip-rap were observed throughout the 1½ Mile Reach. With respect to the four non-riverbank trees assessed at Parcel I8-24-1, this monitoring visit indicated that two were healthy, one was stressed, and one was dead. The three living trees will be inspected again in the summer monitoring visit, and the dead tree will be replaced with a white oak specimen in the fall.

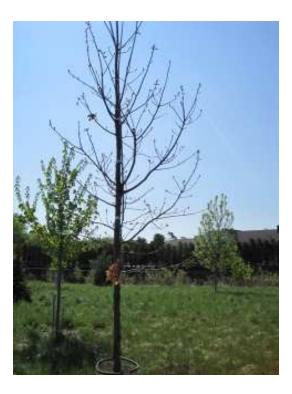
Photo 11: One of four trees monitored on Parcel I8-24-1. This white oak, although not readily apparent in the photo, was considered to be healthy.

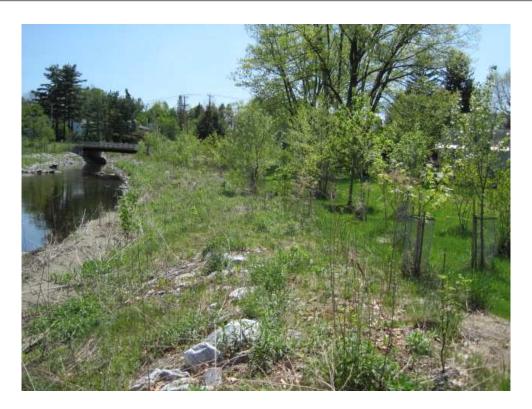
- b. The growth of riverbank vegetation located upstream and downstream of Monitoring Plot 3-E-2 appears to be slower than desired.
 - c. Small bare spots on the ground surface within Monitoring Plot 3-W-3 were noted.

Photo 35: Monitoring Plot 3-W-3, facing downstream. The Pomeroy Avenue Bridge is visible in the background.

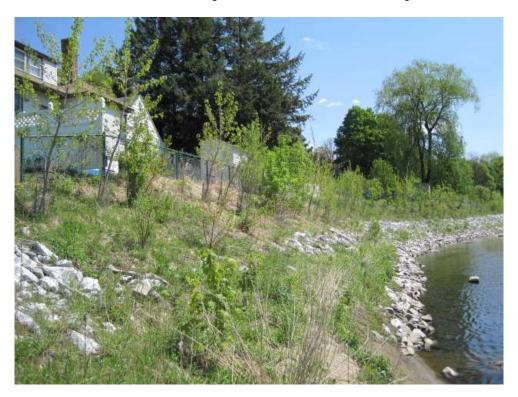
Photo 40: Monitoring Plot 3-E-2, facing downstream.

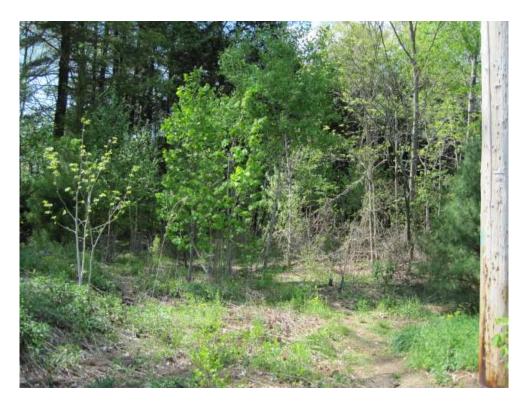
- 4. The qualitative assessment of the non-riverbank trees and shrubs at Parcel I7-1-101 indicated that those plantings were in good condition.
- 5. The shrub counts conducted during the spring monitoring visit, compared to the applicable survival standard of 80%, are summarized in the table on the following page. These data will be presented in the Summer Re-Vegetation Monitoring Report in greater detail, including a calculation of per-acre density for the shrubs in each riverbank area and comparison of that density to the target ("as-built") density to determine percent survivorship. The results are provided in this Spring Re-Vegetation Monitoring Report for preliminary review purposes. They indicate that the shrubs in each area assessed met the 80% survival standard.

Photo 42: Area B, evaluated for shrubs during the Spring 2010 monitoring visit.

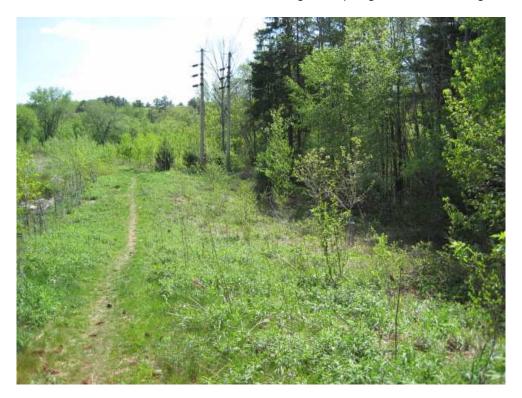
Photo 43: Area C/D, evaluated for shrubs during the Spring 2010 monitoring visit.
